# Truesdale Lake Study

Engineering study of wastewater issues  
and solutions around Truesdale Lake

Town of Lewisboro,  
Westchester County, New York

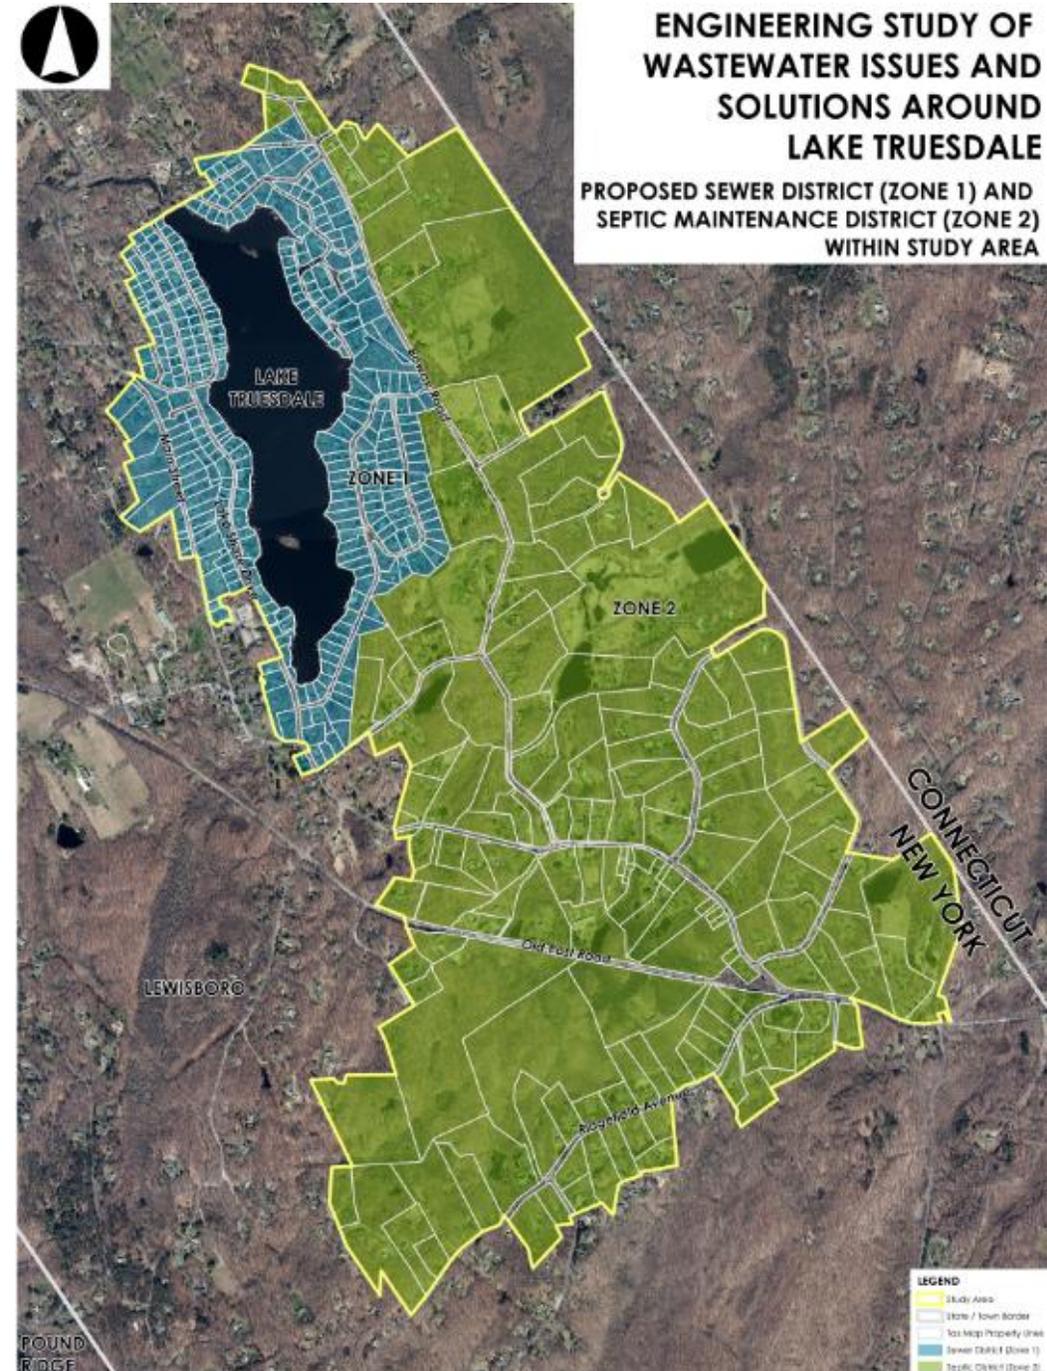
## Study area zones

**Zone 1:**  
Parcels less than 1 acre within  
800-feet (+/-) of  
Lake shore (blue)  
274 residences

**Zone 2:**  
Larger parcels (green)  
145 residences

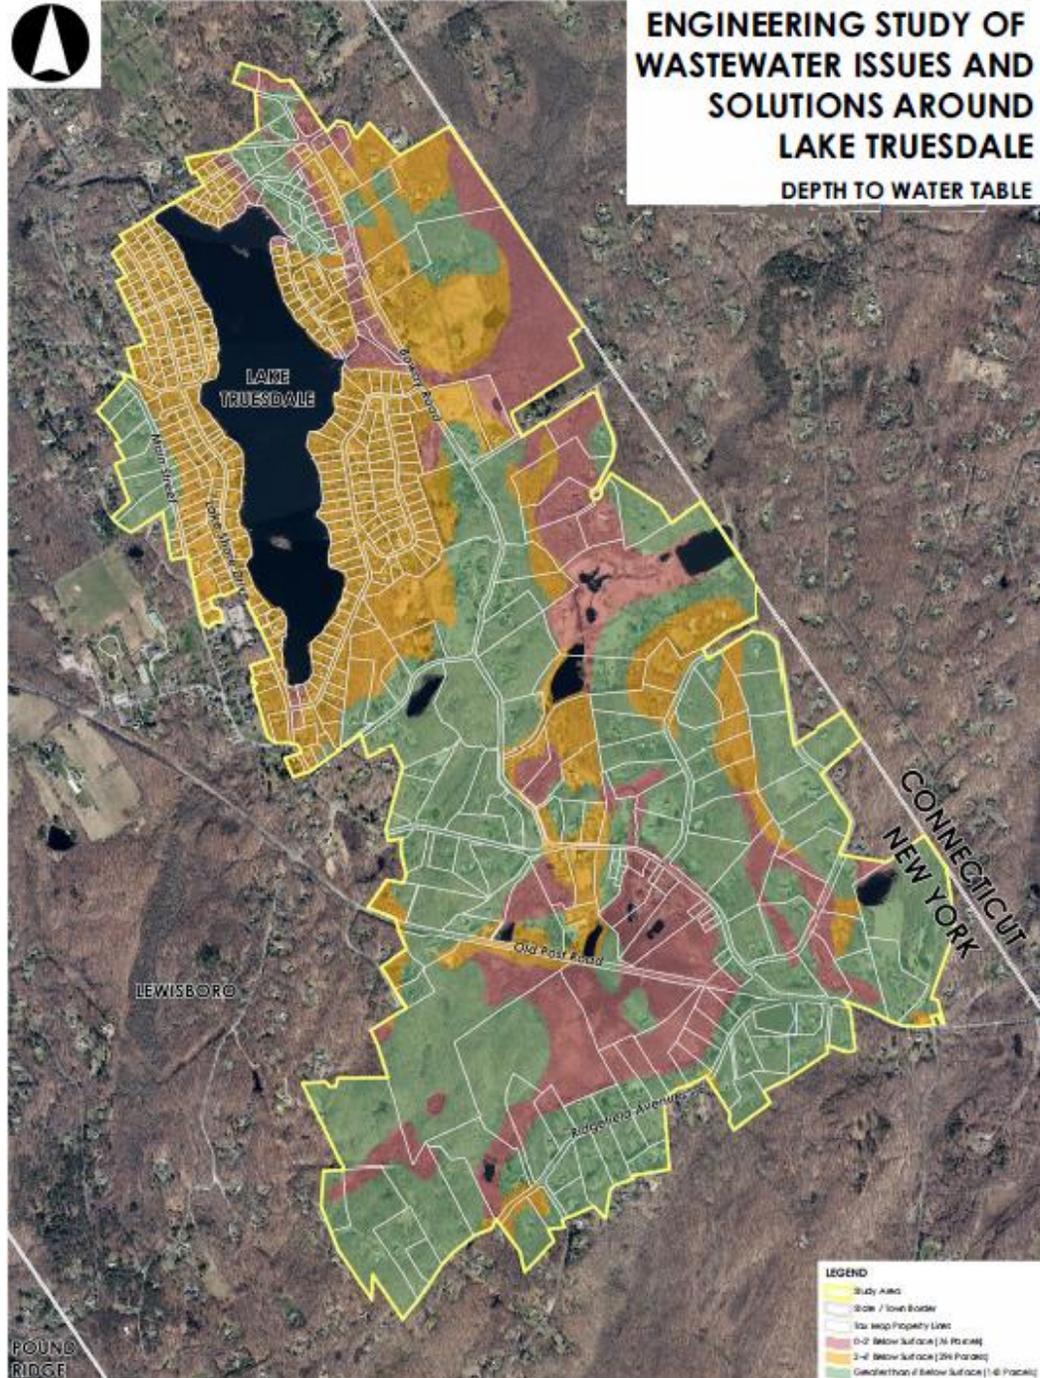
**ENGINEERING STUDY OF  
WASTEWATER ISSUES AND  
SOLUTIONS AROUND  
LAKE TRUESDALE  
DEPTH TO WATER TABLE**

# Depth to Water Table

- One of several critical design considerations
- Adequate vertical separation between absorption fields and groundwater is essential for optimal performance
- WCDOH requirements: 5 feet
- Typical septic system depth: 2.5 feet

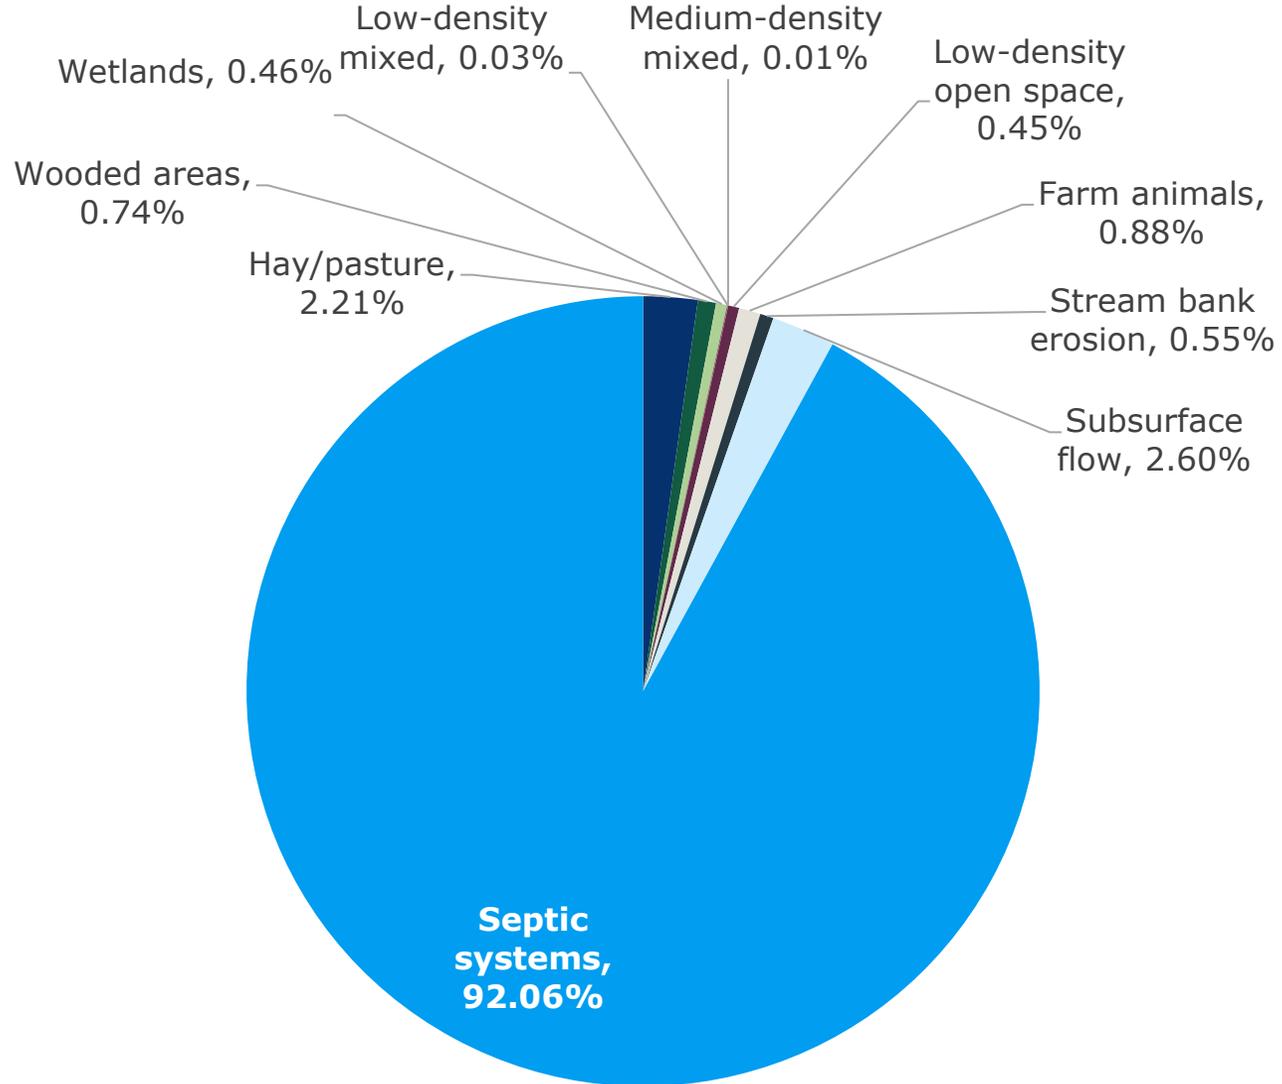
# Phosphorus Loading Sources\*

\*Note that several scenarios of septic failures were modeled for this analysis, the data presented in this pie chart is from the worst-case scenario:

- A. 2 septic failures per Zone  
Underestimation of loading at 100 lb/year
- B. All systems within 200-feet of a water course or well, or those systems located in a shallow water table (presented worst-case)  
Overestimation of loading at 1,200 lb/year
- C. EPA Cited 15% failure  
Median estimation of loading at 403 lb/year
- D. Zero failures  
Unrealistic, shows wildlife contributes 90lb/year loading to the lake

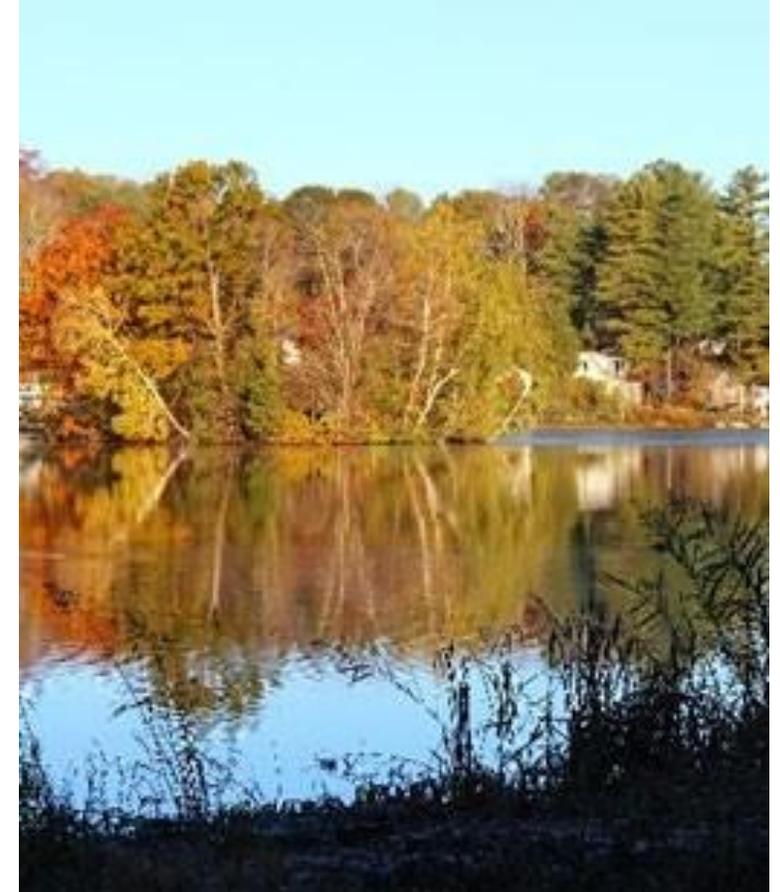
## Zone 1

**Area immediately surrounding lake**

- Low pressure sewers with treatment at the expanded Lewisboro-Katonah Elementary School WWTP
- New effluent outfall at the Waccabuc River
- Serves 274 parcels

## Zone 2

**Upland area within project limits**

- Continued onsite treatment with addition of enhanced treatment units (nutrient removal) and inspection and repair of existing systems
- Lot sizes and location will support long term commitment to onsite systems (145 systems)
- Includes development of septic maintenance district and a septic maintenance program: evaluate systems, system repairs and remediations, long-term maintenance program
